Salt River Project Navajo Generation Station
Page, AZ

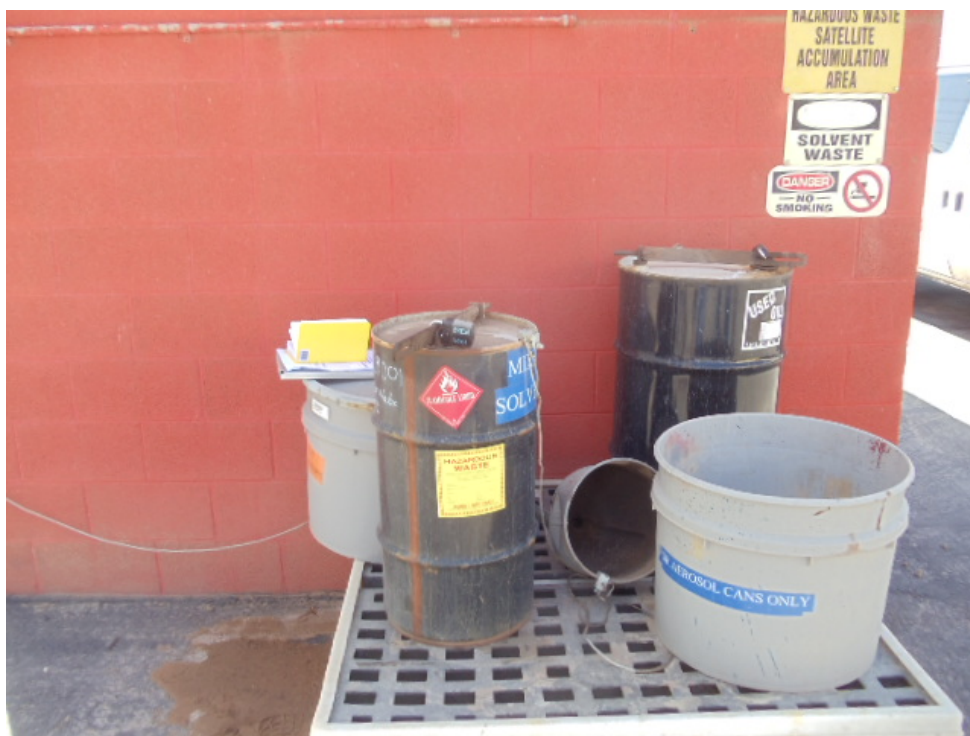
Photo Number: 36
Photographer: John Dixon
Camera: Sony Cybershot
DSC-W370
Date: 4/16/2012
Time: 1339
Description: Fuel Lab SAA.
View of the area identified by
facility personnel as the Fuel Lab
SAA. One, 16-gallon hazardous
waste solvent storage container
(holding approximately 10
gallons); one empty container for
aerosol cans; and one 35-gallon
used oil storage container (holding
approximately one gallon). The
hazardous and nonhazardous
wastes are generated inside the
Fuel Lab building.

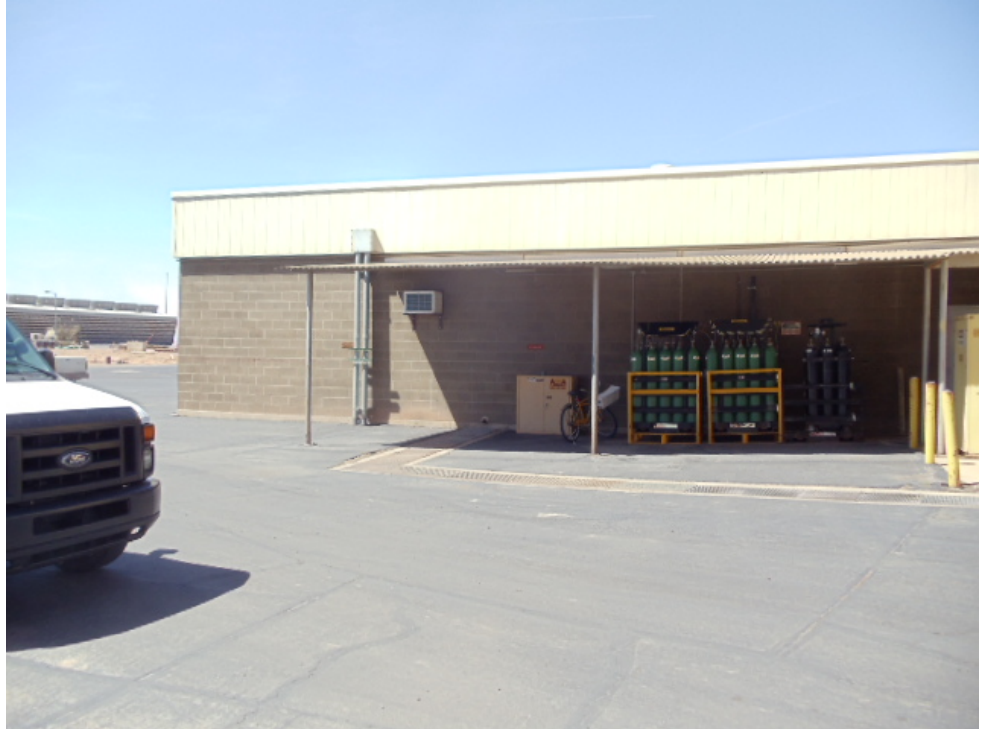
Photo Number: 37
Photographer: John Dixon
Camera: Sony Cybershot
DSC-W370
Date: 4/16/2012
Time: 1339
Description: View of the Fuel
Lab building from the area
identified as the Fuel Lab SAA.
The area identified as the Fuel Lab
SAA may not be near the point of
generation.

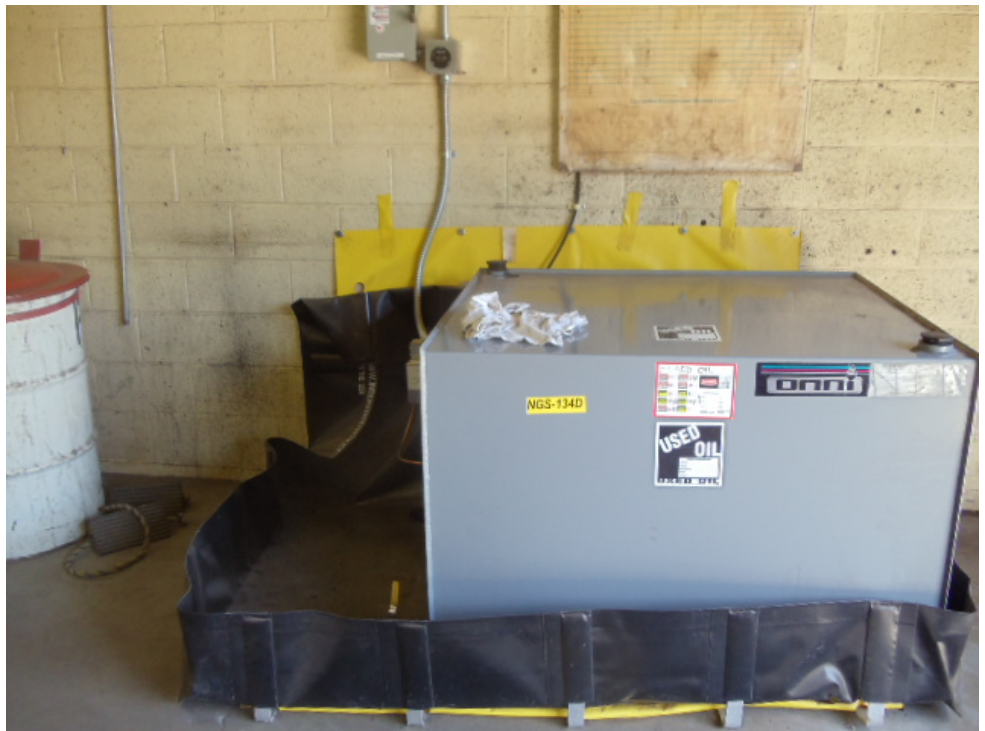
Photo Number: 38
Photographer: John Dixon
Camera: Sony Cybershot
DSC-W370
Date: 4/16/2012
Time: 1415
Description: Auto Bay. View
of a 500-gallon used oil storage
tank. The used oil storage tank is
structurally sound and labeled with
the words "used oil."

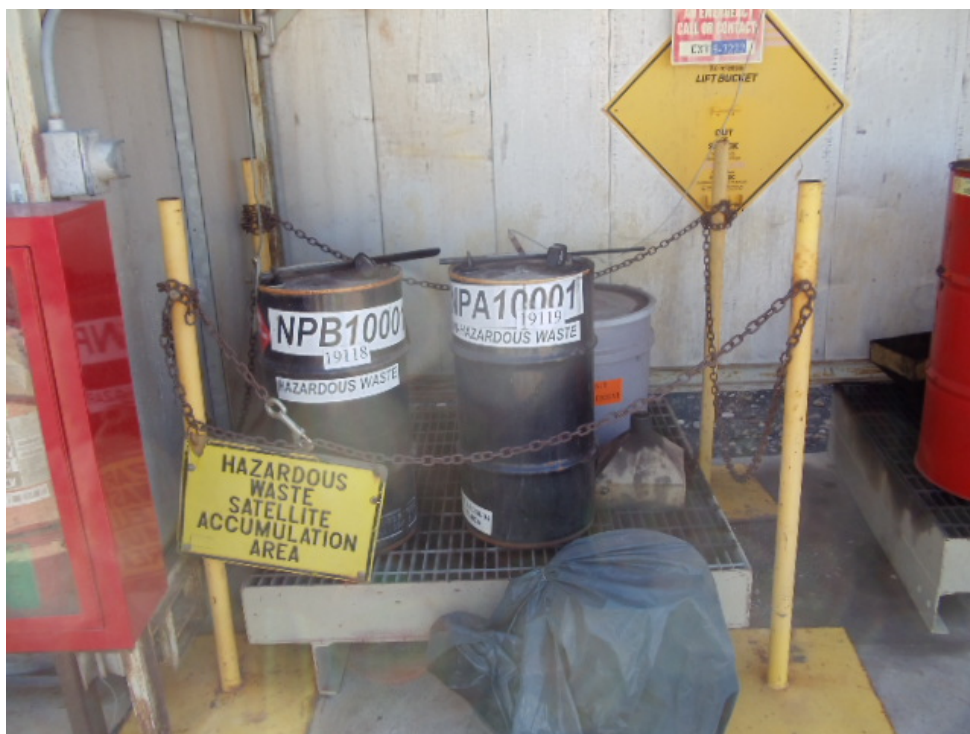
Photo Number: 39
Photographer: John Dixon
Camera: Sony Cybershot
DSC-W370
Date: 4/16/2012
Time: 1431
Description: Railroad SAA.
View one, 16-gallon satellite
accumulation container holding
hazardous waste solvents
(approximately full); and one, 16-
gallon container holding
nonhazardous paint wastes
(approximately 10 gallons) in the
Railroad SAA. The satellite
accumulation container is
structurally sound, labeled to
identify its contents, closed, and
near the point of generation.

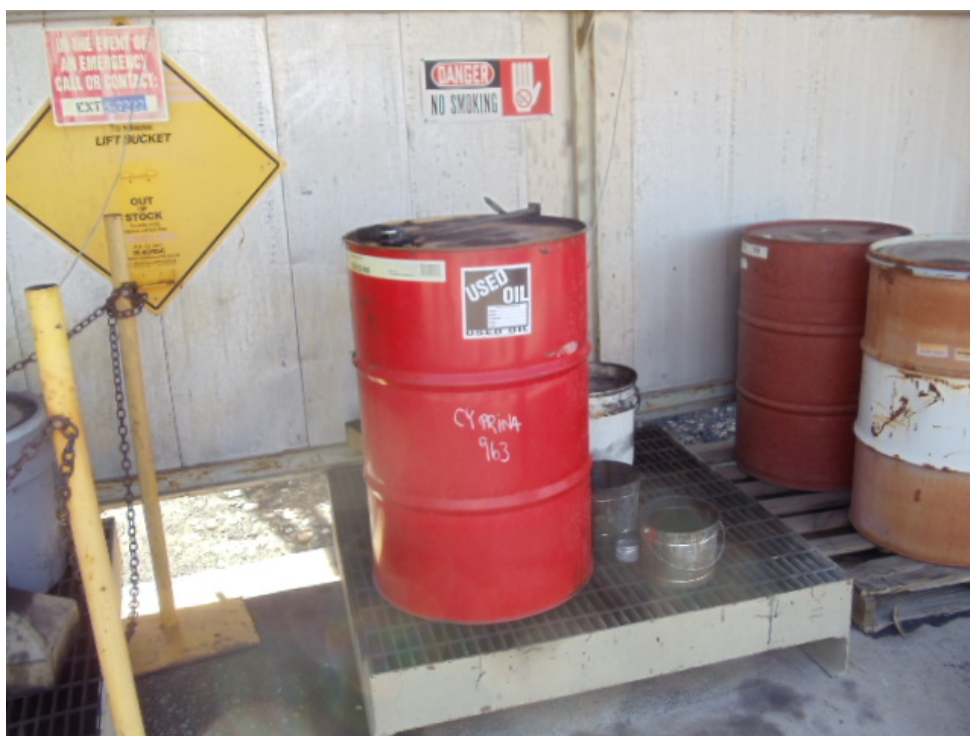
Photo Number: 40
Photographer: John Dixon
Camera: Sony Cybershot
DSC-W370
Date: 4/16/2012
Time: 1431
Description: Railroad SAA.
View of one, 55-gallon used oil
storage container in the Railroad
SAA. The used oil storage
container is structurally sound and
labeled with the words "used oil."
One of the one-gallon containers to
the right holds approximately $\frac{3}{4}$
gallons of used oil, and is not
labeled with the words "used oil."

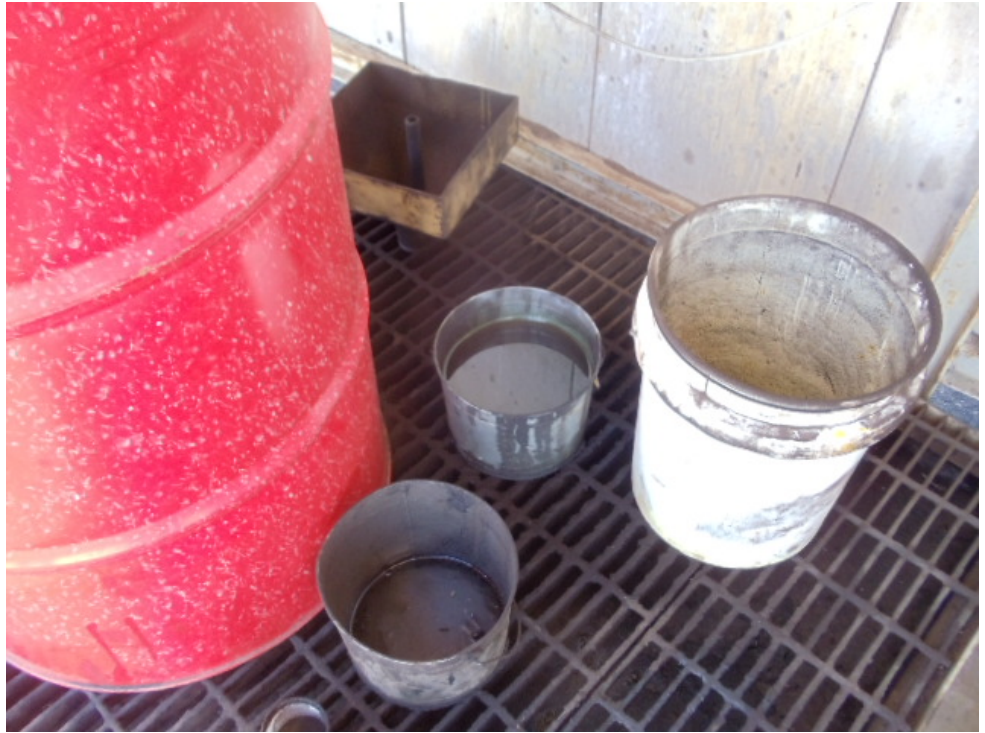
Photo Number: 41
Photographer: John Dixon
Camera: Sony Cybershot
DSC-W370
Date: 4/16/2012
Time: 1431
Description: Railroad SAA.
View of two, one-gallon containers
shown in Photo 40. One is empty,
the other holds used oil
(approximately $\frac{3}{4}$ full). The used
oil storage container is structurally
sound, but not labeled with the
words “used oil.”

Photo Number: 42
Photographer: John Dixon
Camera: Sony Cybershot
DSC-W370
Date: 4/16/2012
Time: 1433
Description: Railroad SAA.
View of the unlabeled, one-gallon
used oil storage container shown in
Photo 41 after facility
representatives labeled the
container with the words “used
oil.”

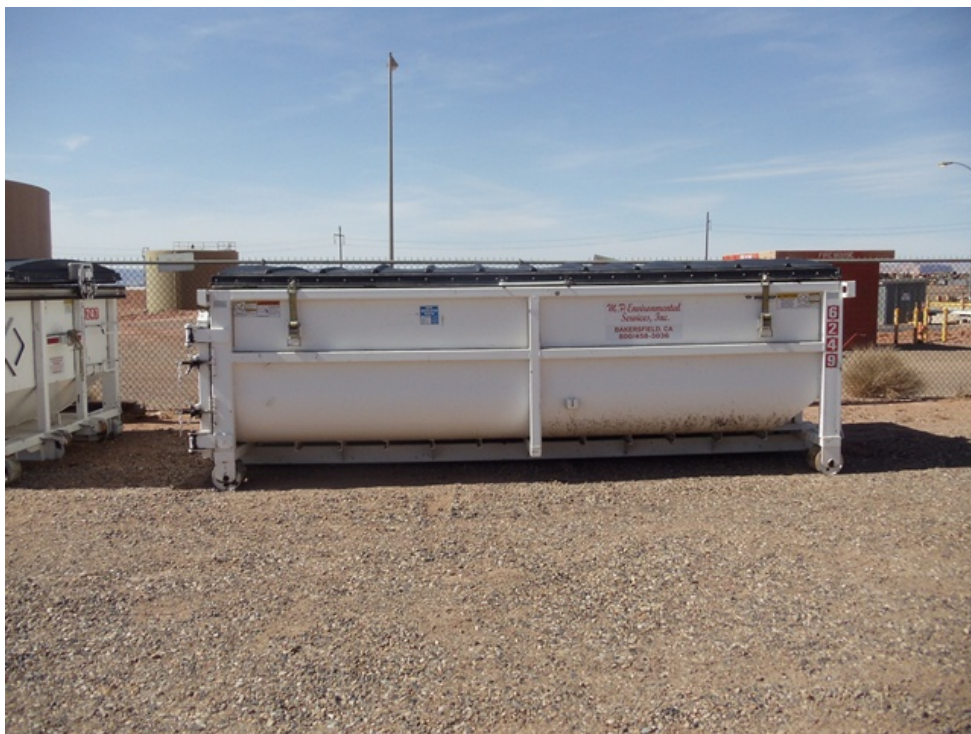
Photo Number: 43
Photographer: John Dixon
Camera: Sony Cybershot
DSC-W370
Date: 4/16/2012
Time: 1520
Description: 180-day
Hazardous Waste Storage Area.
View of one of two, 20-cubic-yard
rolloff containers for nonhazardous
oily cleanup debris and rags
storage.

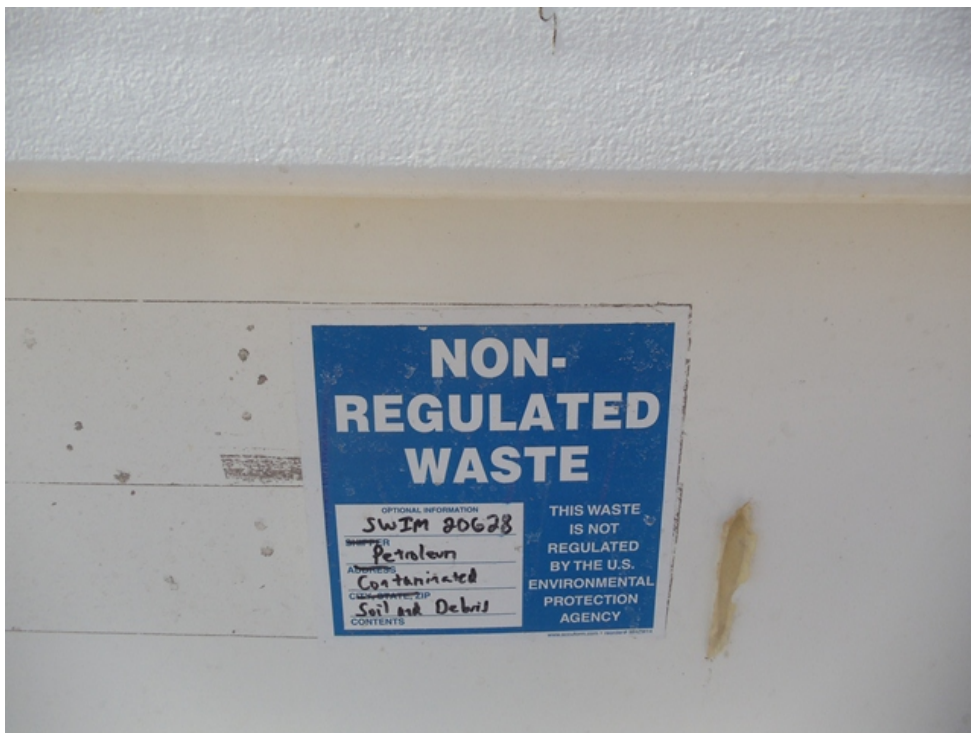
Photo Number: 44
Photographer: John Dixon
Camera: Sony Cybershot
DSC-W370
Date: 4/16/2012
Time: 1520
Description: 180-day
Hazardous Waste Storage Area.
View of one of two, 20-cubic-yard
rolloff containers for nonhazardous
oily cleanup debris and rags
storage.

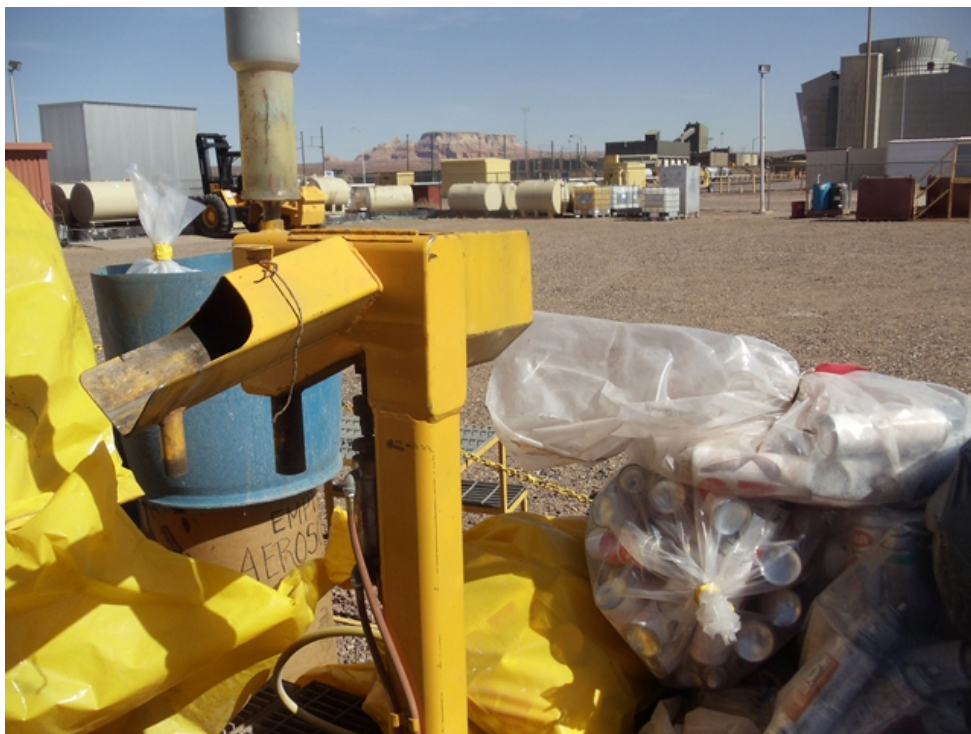
Photo Number: 45
Photographer: John Dixon
Camera: Sony Cybershot
DSC-W370
Date: 4/16/2012
Time: 1524
Description: 180-day
Hazardous Waste Storage Area.
View of the aerosol can puncturing
unit in the hazardous waste storage
area.

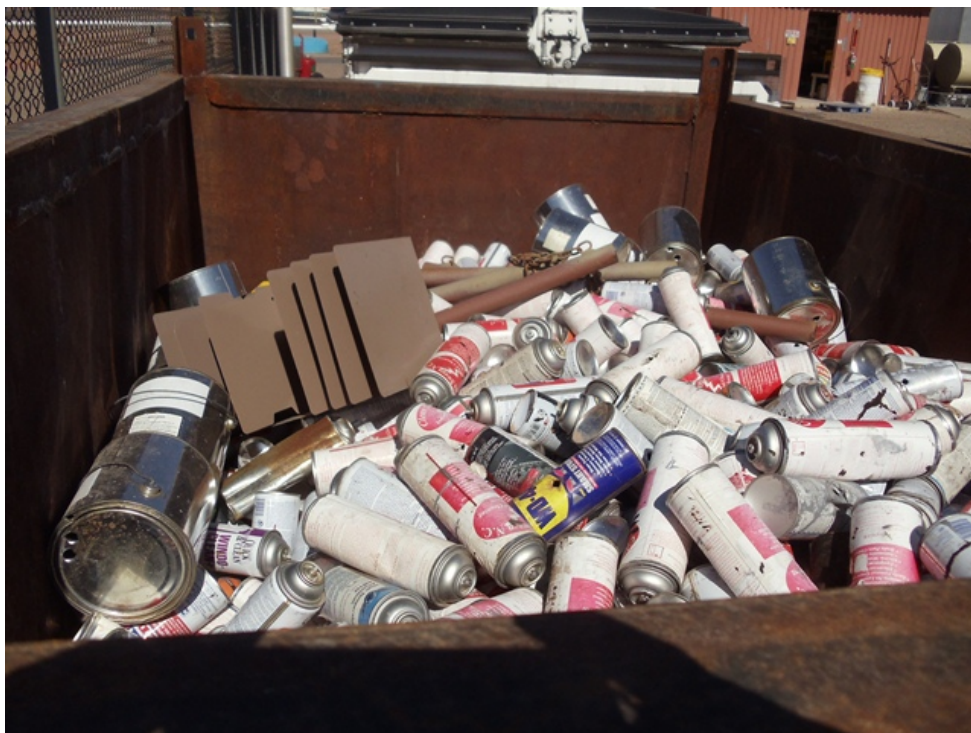
Photo Number: 46
Photographer: John Dixon
Camera: Sony Cybershot
DSC-W370
Date: 4/16/2012
Time: 1525
Description: 180-day
Hazardous Waste Storage Area.
View of punctured, drained aerosol
cans in the hazardous waste storage
area. Punctured, drained cans are
recycled as scrap steel. Liquids
drained from the cans are
accumulated in a satellite
accumulation container.

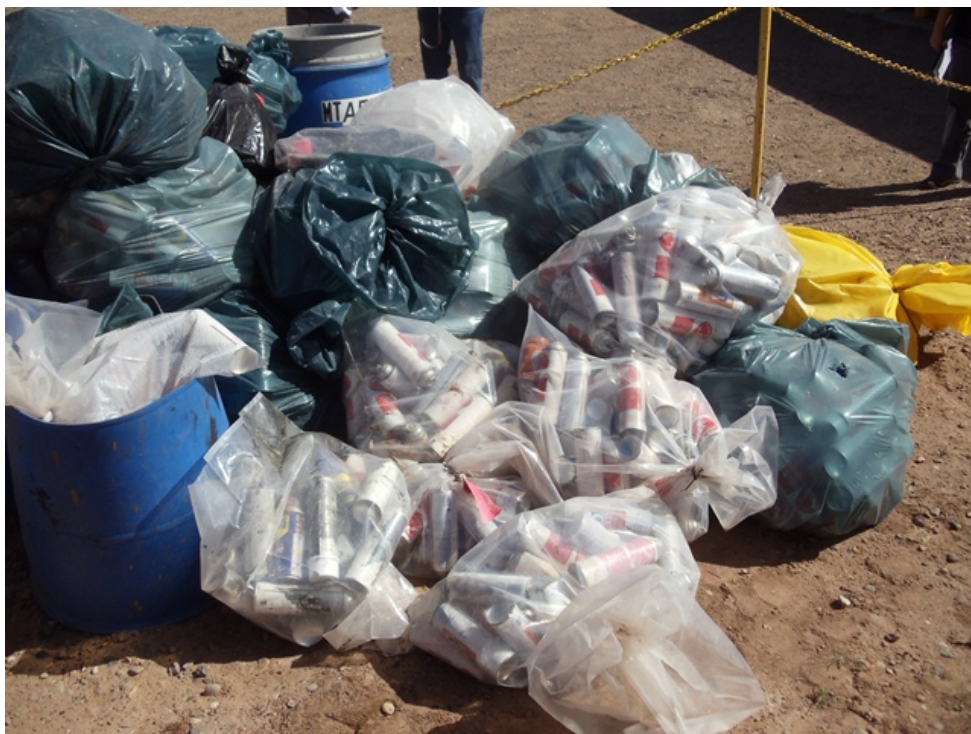
Photo Number: 47
Photographer: John Dixon
Camera: Sony Cybershot
DSC-W370
Date: 4/16/2012
Time: 1525
Description: 180-day
Hazardous Waste Storage Area.
View of aerosol cans waiting
puncturing. Per facility
representatives, this volume
represents approximately two
weeks of accumulation.

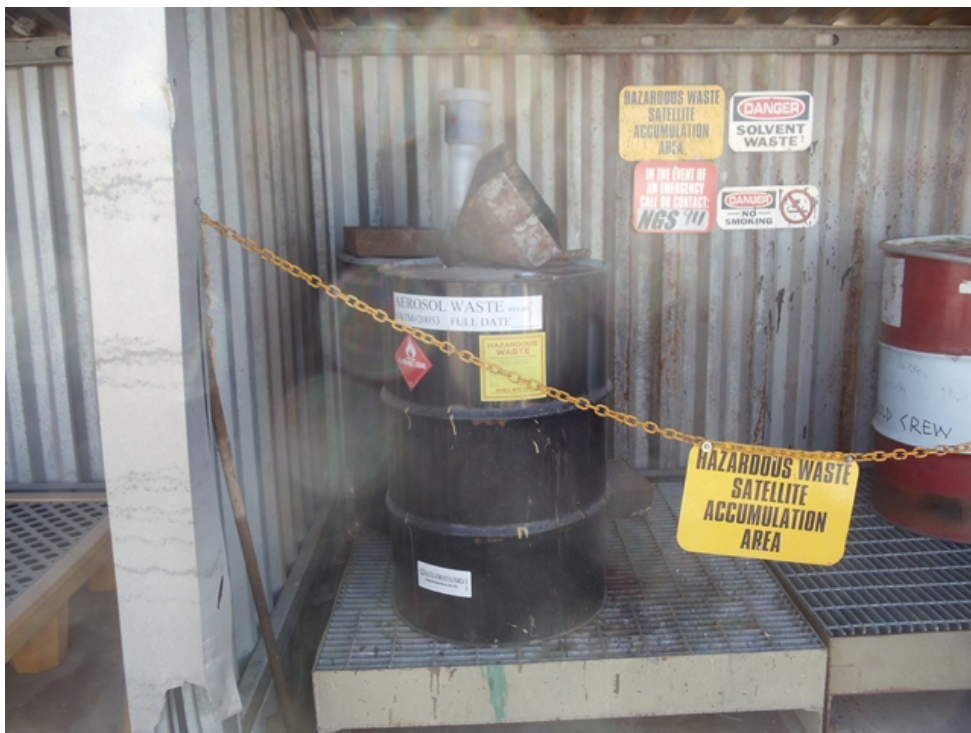
Photo Number: 48
Photographer: John Dixon
Camera: Sony Cybershot
DSC-W370
Date: 4/16/2012
Time: 1528
Description: 180-day
Hazardous Waste Storage Area.
View of the SAA for aerosol can
puncturing waste. The satellite
accumulation container holds
approximately 50 gallons of
hazardous waste, and is structurally
sound, closed, at near the point of
generation.

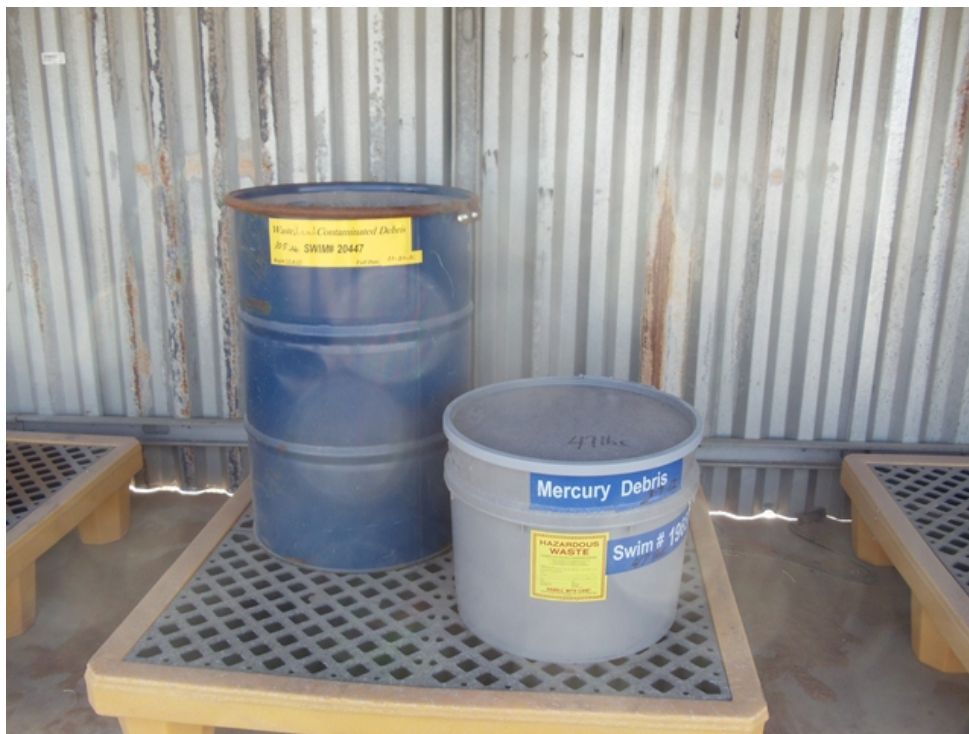
Photo Number: 49
Photographer: John Dixon
Camera: Sony Cybershot
DSC-W370
Date: 4/16/2012
Time: 1531
Description: 180-day
Hazardous Waste Storage Area.
View of the two, hazardous waste
storage containers in the hazardous
waste storage area at the time of
the CEI. One, 20-gallon container
holding D009 characteristic
mercury debris (dated 3/9/12); and
one, 55-gallon container holding
D008 characteristic lead-
contaminated debris (dated
11/21/11). Both hazardous waste
storage containers are structurally
sound, closed, and labeled with the
words "hazardous waste."

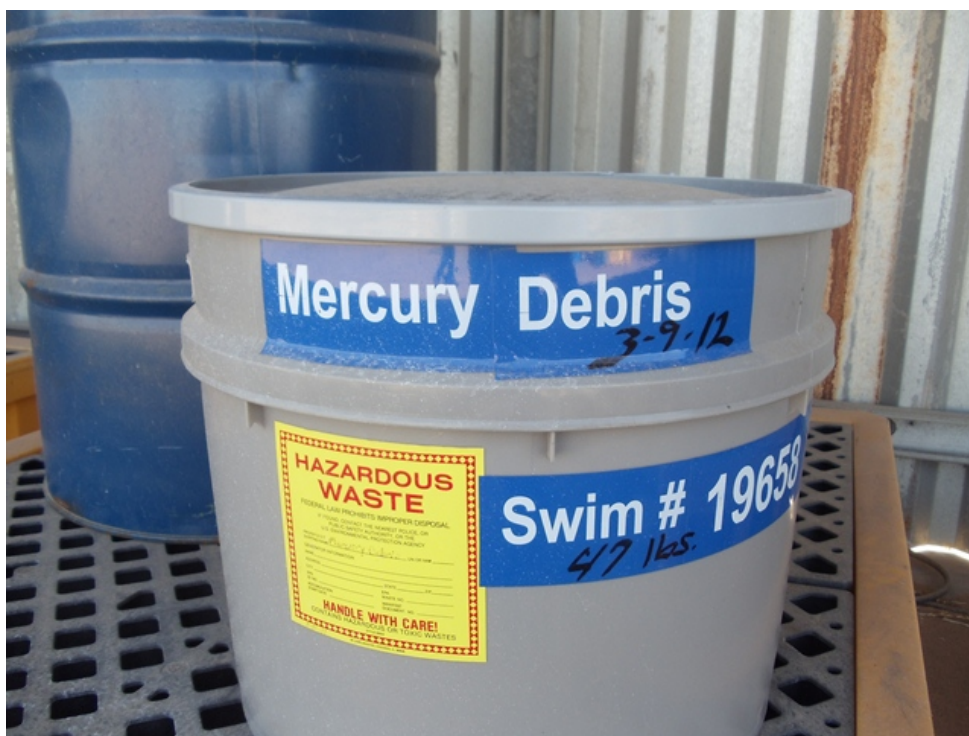
Photo Number: 50
Photographer: John Dixon
Camera: Sony Cybershot
DSC-W370
Date: 4/16/2012
Time: 1531
Description: 180-day
Hazardous Waste Storage Area.
Close-up view of the mercury
debris hazardous waste storage
container shown in Photo 49.

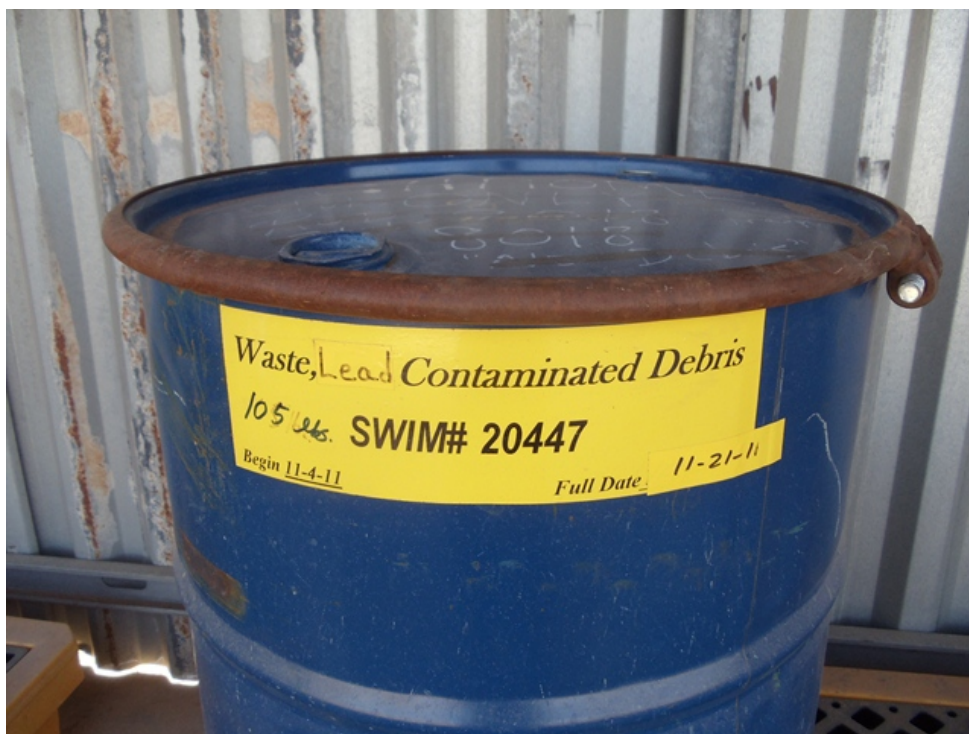
Photo Number: 51
Photographer: John Dixon
Camera: Sony Cybershot
DSC-W370
Date: 4/16/2012
Time: 1531
Description: 180-day
Hazardous Waste Storage Area.
Close-up view of the lead-
contaminated debris hazardous
waste storage container shown in
Photo 49. Container not labeled
with the words "hazardous waste."

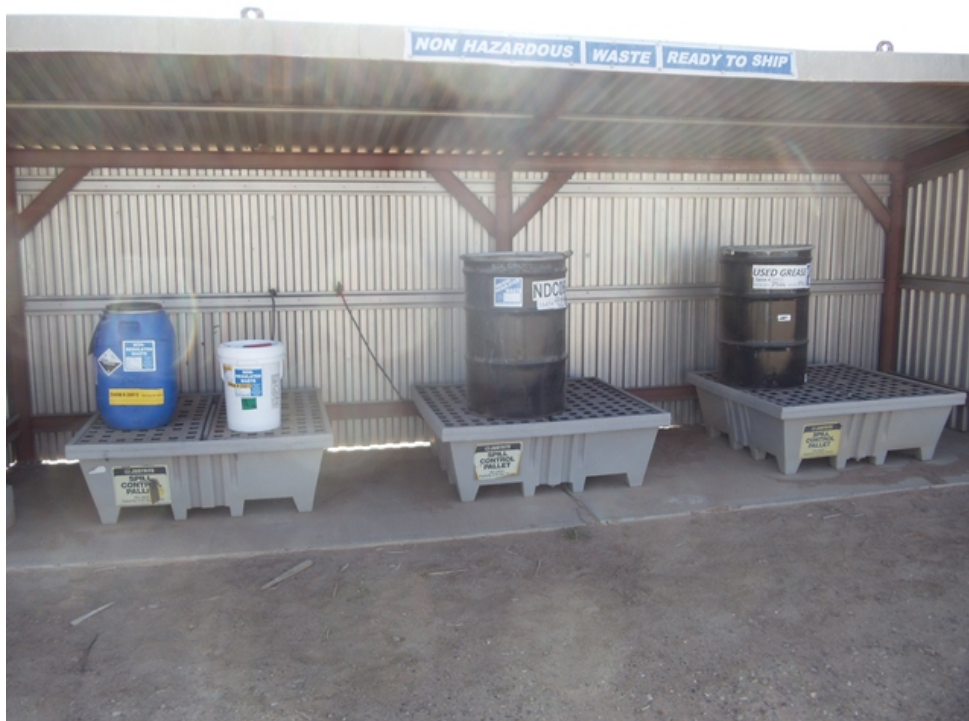
Photo Number: 52
Photographer: John Dixon
Camera: Sony Cybershot
DSC-W370
Date: 4/16/2012
Time: 1534
Description: 180-day
Hazardous Waste Storage Area.
Nonhazardous wastes (e.g., grease,
nonhazardous waste resin,
nonhazardous paint) in storage at
the time of the CEI.

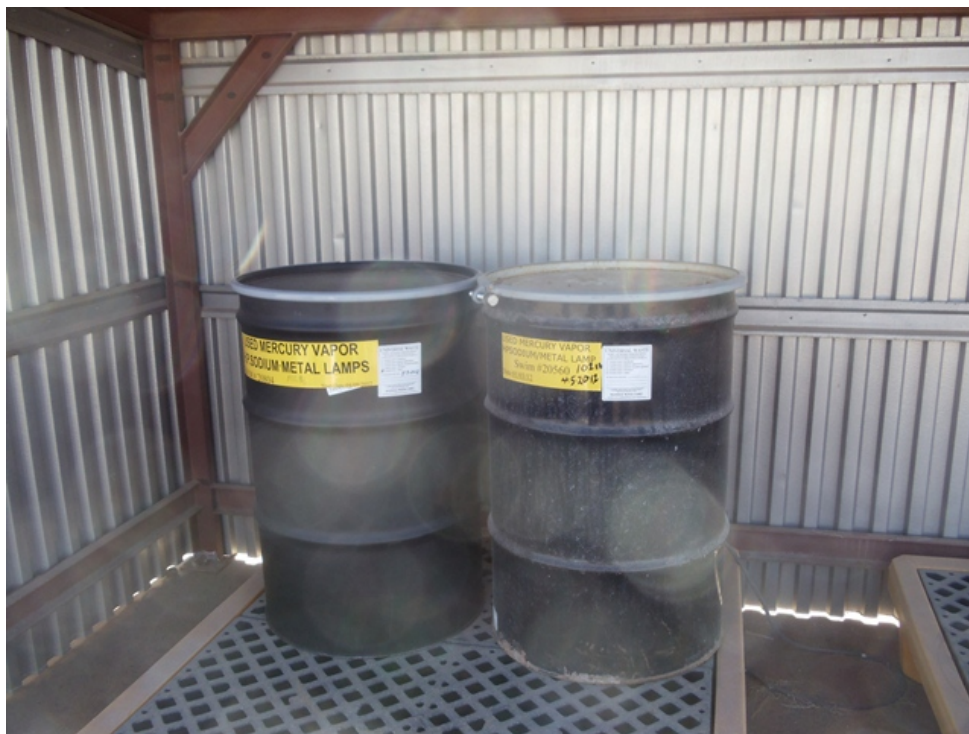
Photo Number: 53
Photographer: John Dixon
Camera: Sony Cybershot
DSC-W370
Date: 4/16/2012
Time: 1536
Description: 180-day
Hazardous Waste Storage Area.
Two, 55-gallon containers holding
odd-shaped and/or broken
universal waste lamps. The
containers are managed as
universal waste lamps storage
containers. The universal waste
lamps storage containers are
structurally sound, closed, labeled
with the words "universal waste
lamps," and dated 4/5/12 and
4/9/12.

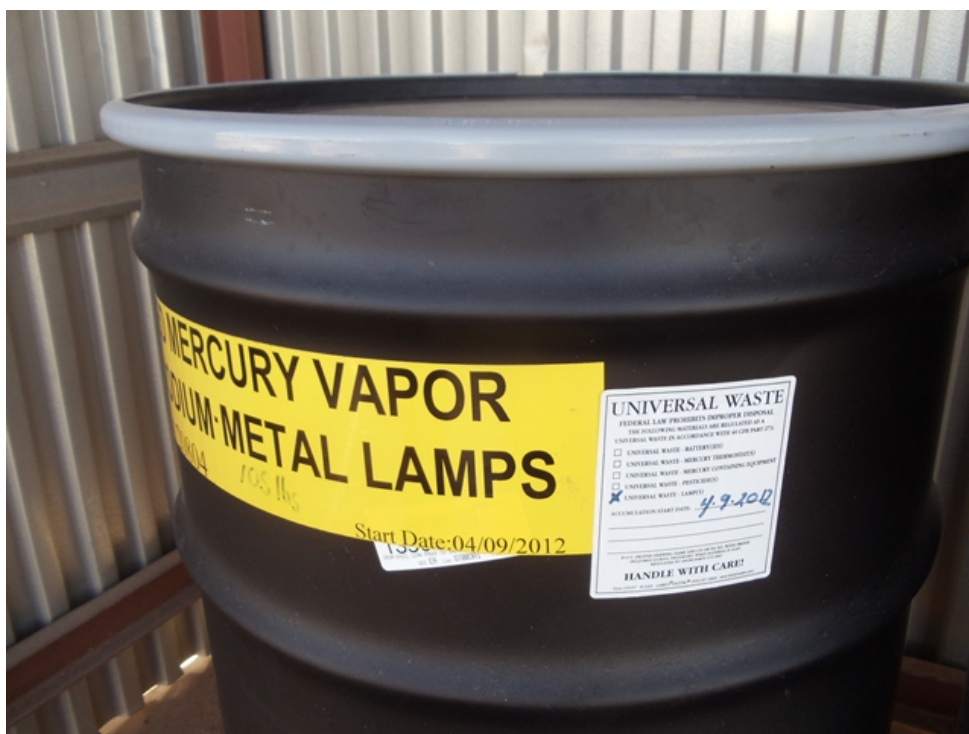
Photo Number: 54
Photographer: John Dixon
Camera: Sony Cybershot
DSC-W370
Date: 4/16/2012
Time: 1536
Description: 180-day
Hazardous Waste Storage Area.
Close-up view of the labeling on
one of the two, 55-gallon universal
waste lamps storage containers
shown in Photo 53.

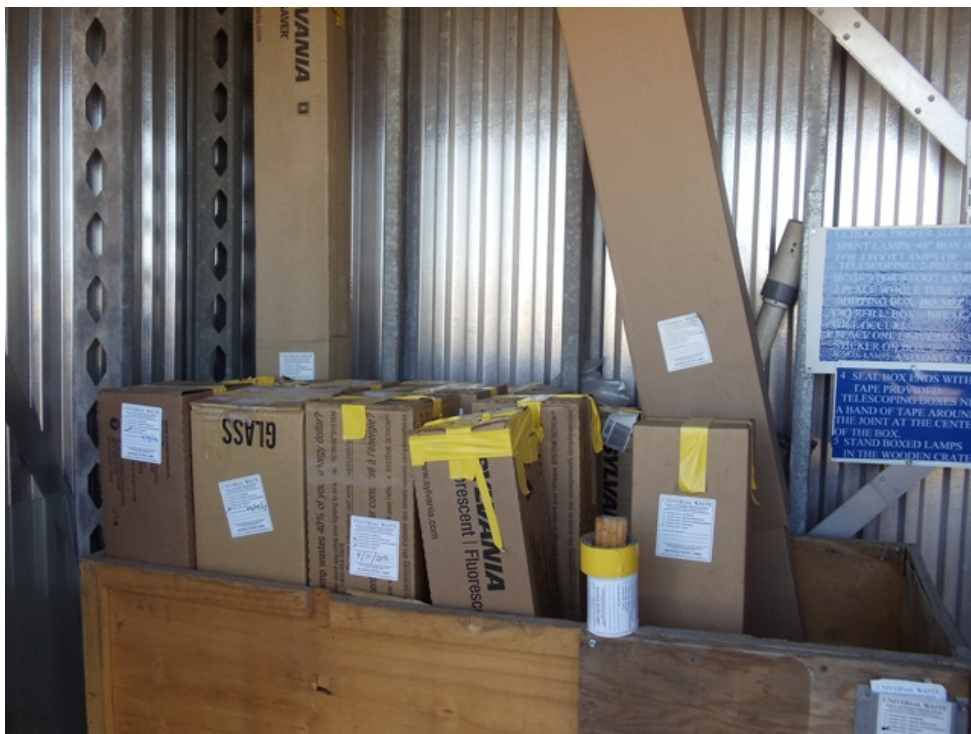
Photo Number: 55
Photographer: John Dixon
Camera: Sony Cybershot
DSC-W370
Date: 4/16/2012
Time: 1544
Description: 180-day
Hazardous Waste Storage Area.
View of the 15 universal waste
lamps storage building. All are
structurally sound, closed, labeled
with the words "universal waste
lamps," and dated (earliest date is
2/14/12).

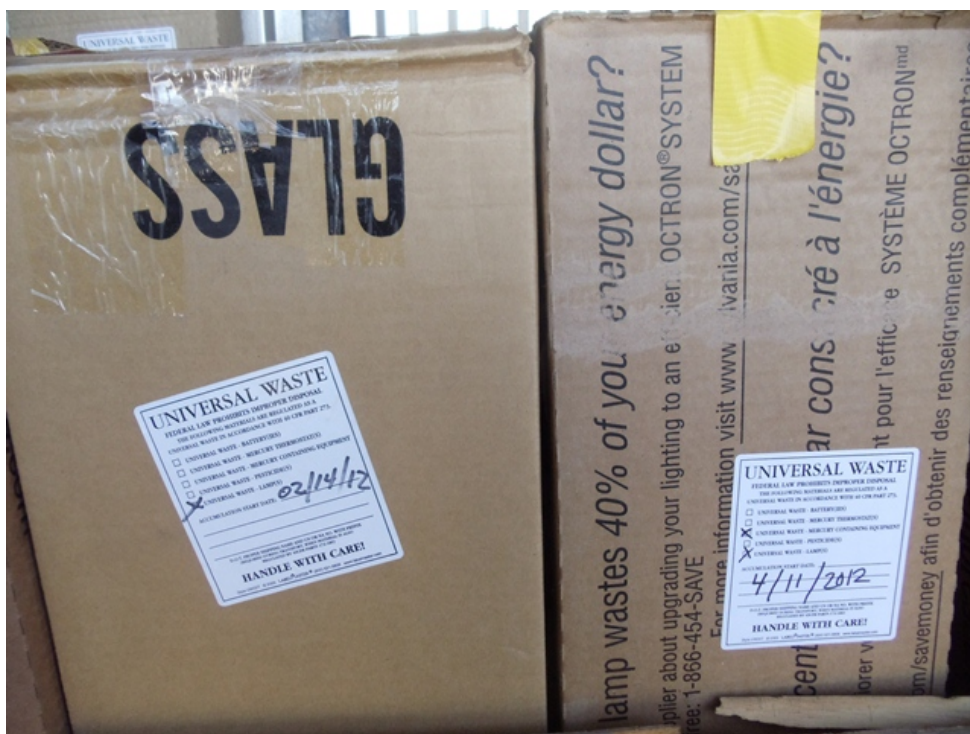
Photo Number: 56
Photographer: John Dixon
Camera: Sony Cybershot
DSC-W370
Date: 4/16/2012
Time: 1544
Description: 180-day
Hazardous Waste Storage Area.
Close-up view of the labeling and
closed containers for two of the 15
universal waste lamps storage
containers shown in Photo 55.

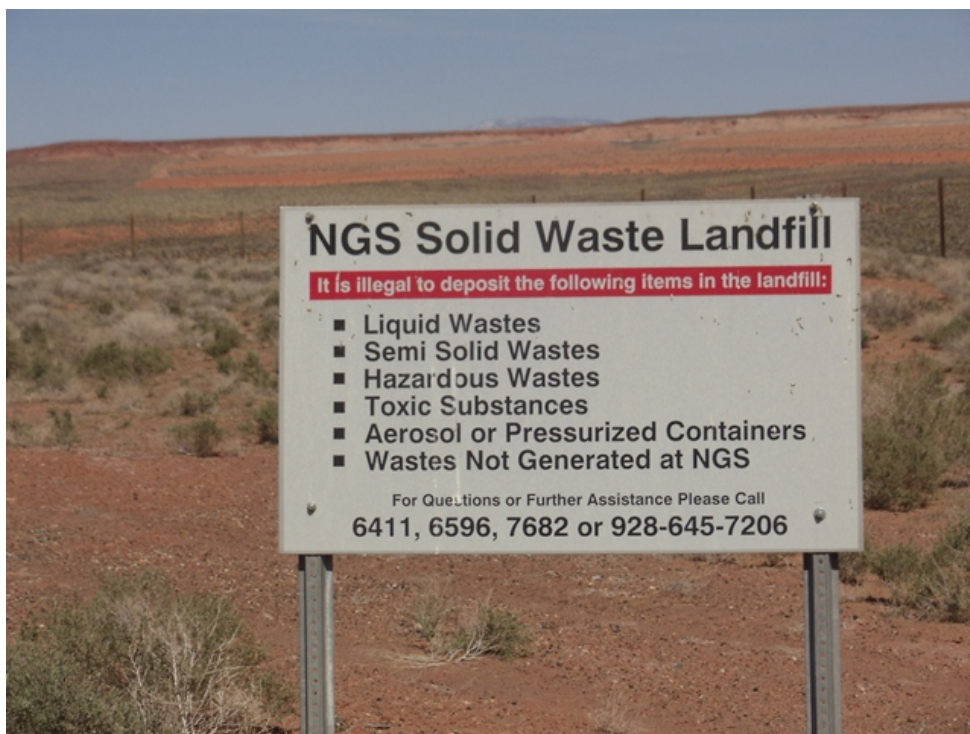
Photo Number: 57
Photographer: John Dixon
Camera: Sony Cybershot
DSC-W370
Date: 4/16/2012
Time: 1443
Description: Solid Waste
Landfill. View of the sign posted
at the solid waste landfill, listing
types of waste prohibited from
disposal.

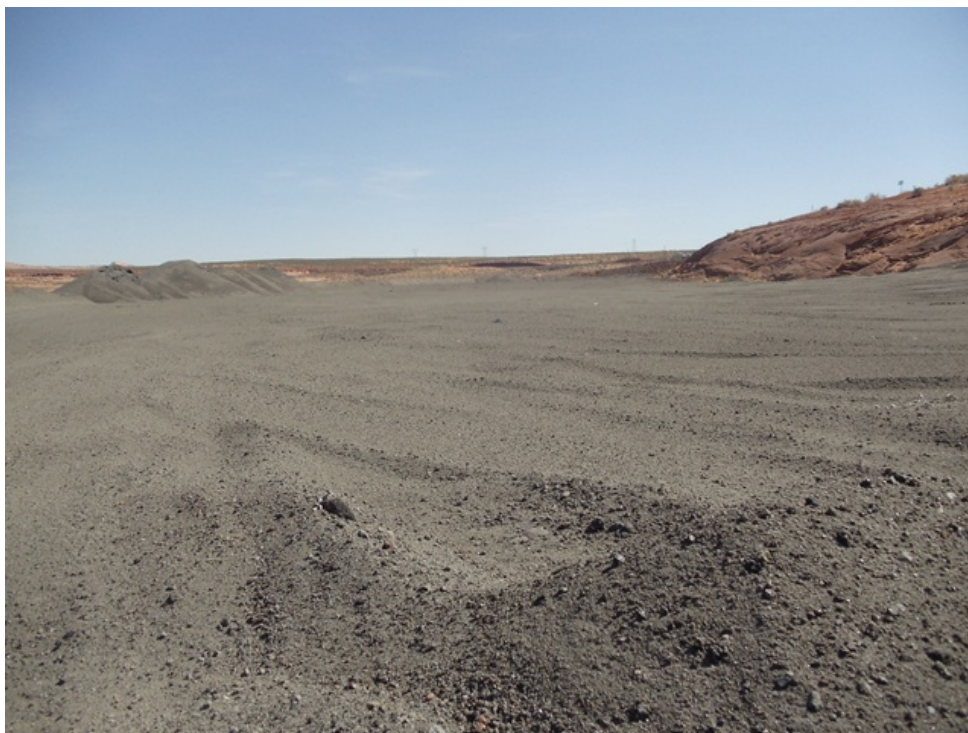
Photo Number: 58
Photographer: John Dixon
Camera: Sony Cybershot
DSC-W370
Date: 4/16/2012
Time: 1450
Description: Solid Waste
Landfill. View across the top of
the solid waste landfill. Bottom
ash is used as daily cover.

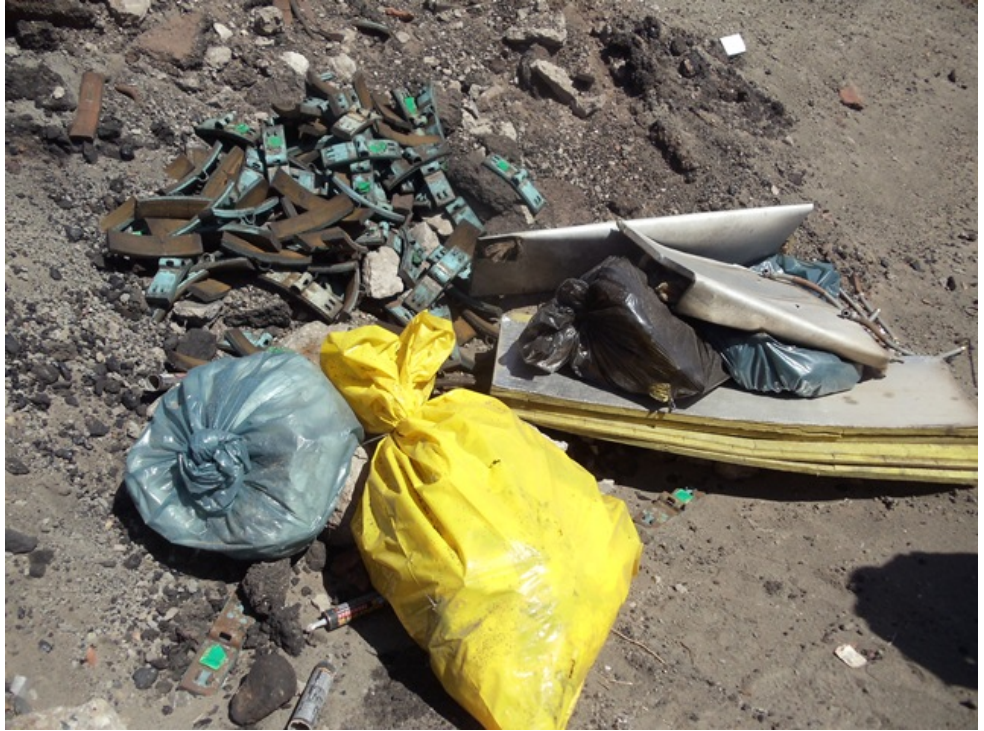
Photo Number: 59
Photographer: John Dixon
Camera: Sony Cybershot
DSC-W370
Date: 4/16/2012
Time: 1449
Description: Solid Waste
Landfill. View of current day's
solid waste added to the landfill
unit. The solid waste consists of
non-asbestos brake pads and
general debris.

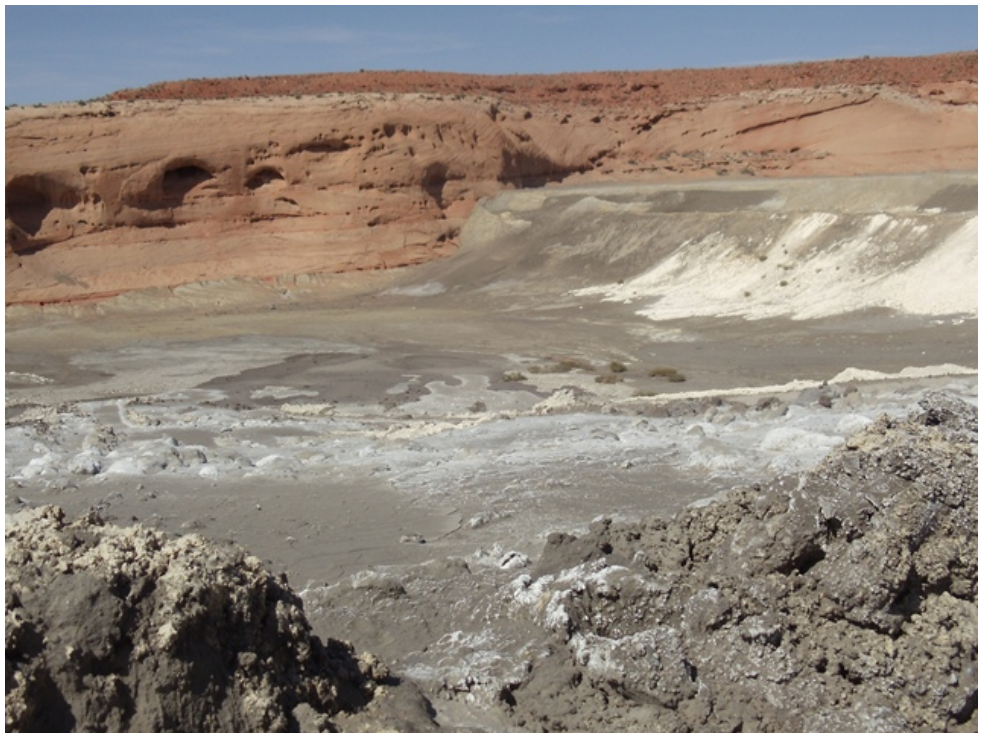
Photo Number: 60
Photographer: John Dixon
Camera: Sony Cybershot
DSC-W370
Date: 4/16/2012
Time: 1458
Description: Ash Disposal
Area. View of the ash disposal
area, used for land disposal of
unsold fly ash, bottom ash, and
scrubber waste (calcium sulfate).

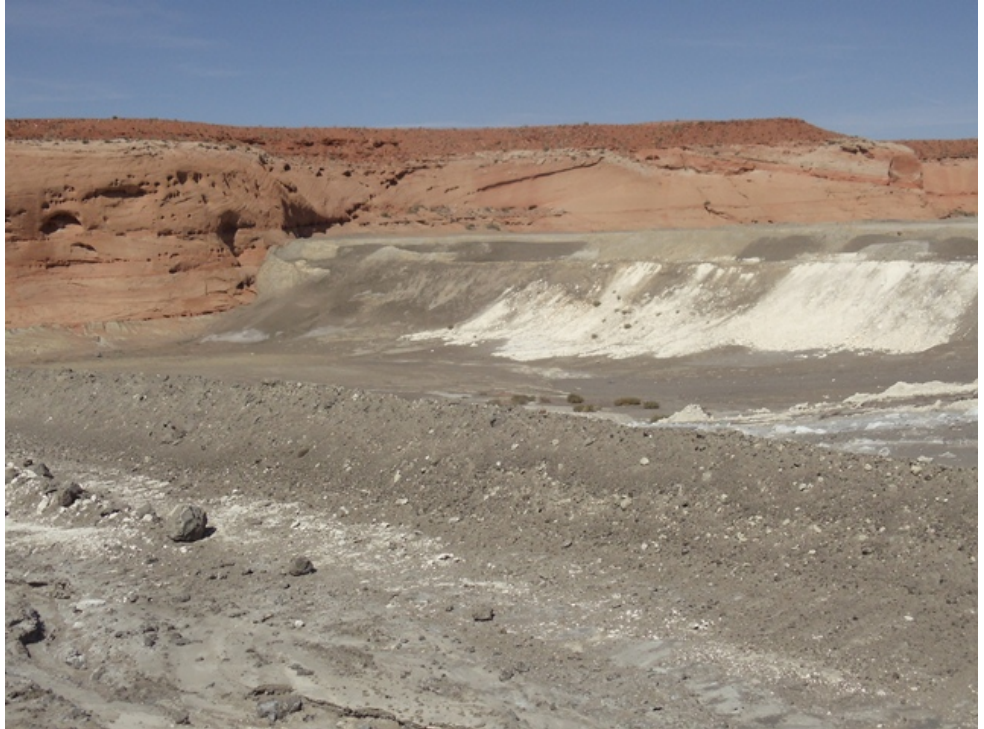
Photo Number: 61
Photographer: John Dixon
Camera: Sony Cybershot
DSC-W370
Date: 4/16/2012
Time: 1458
Description: Ash Disposal
Area. Another view of the ash
disposal area, used for land
disposal of unsold fly ash, bottom
ash, and scrubber waste (calcium
sulfate).

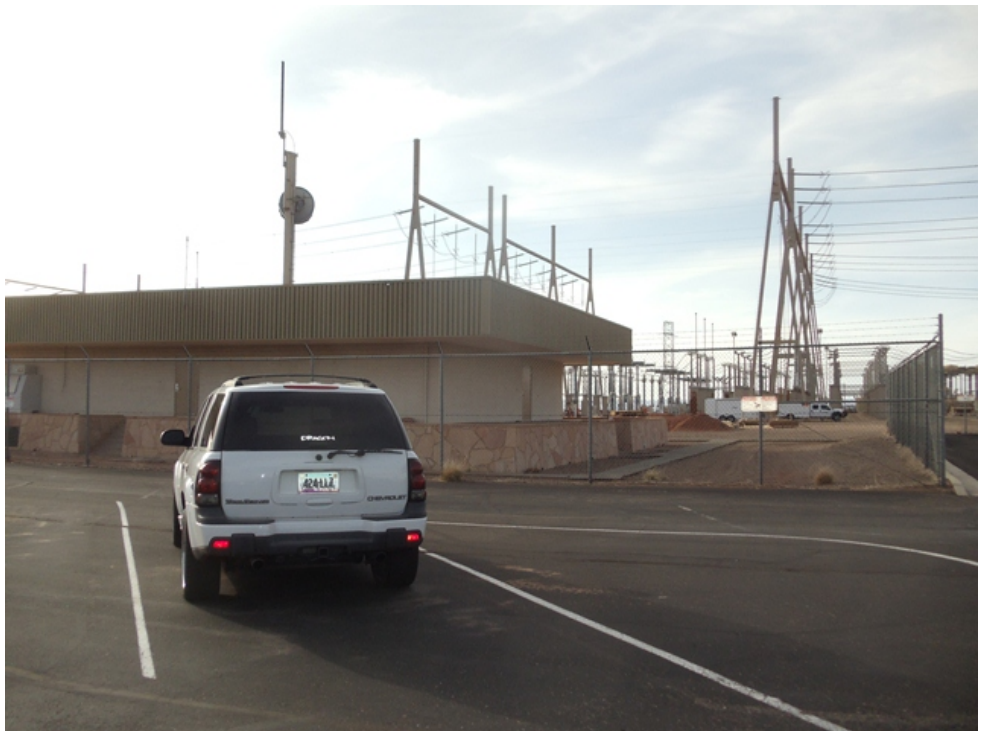
Photo Number: 62
Photographer: John Dixon
Camera: Sony Cybershot
DSC-W370
Date: 4/16/2012
Time: 1723
Description: View of APS
Substation onsite, from SRP
parking lot.

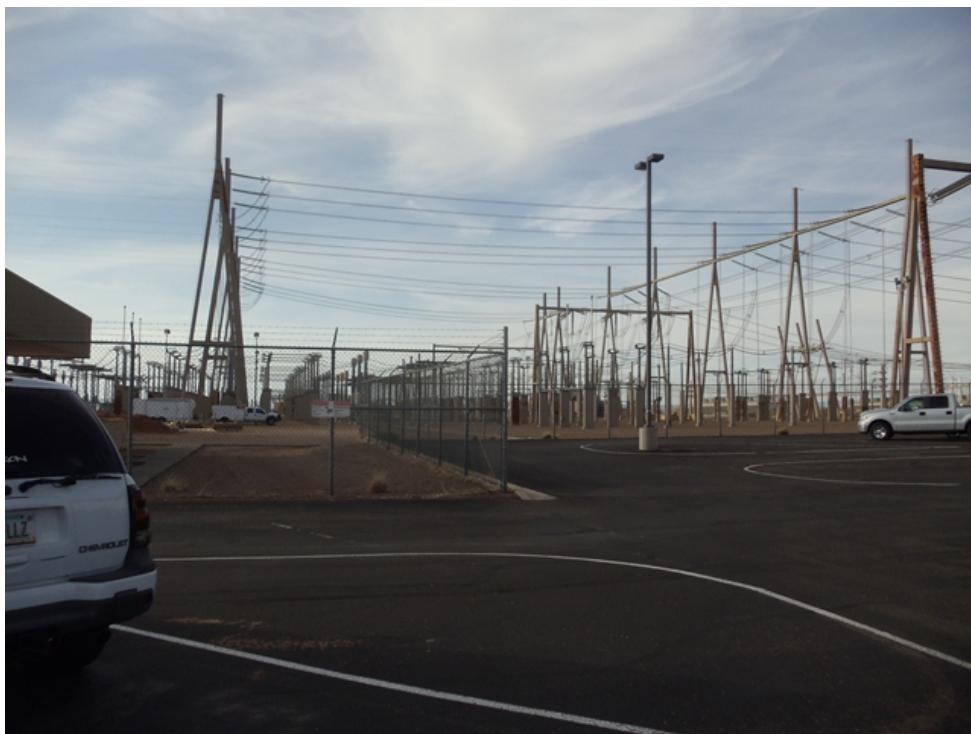
Photo Number: 63
Photographer: John Dixon
Camera: Sony Cybershot
DSC-W370
Date: 4/16/2012
Time: 1723
Description: View of APS
Substation onsite, from SRP
parking lot.
